## **Garry Oak Park Restoration at 1436 Ryan Street**

ER390 – Habitat Restoration Project  
Restoration of Natural Systems Program  
Andrew Walker  
V00137194

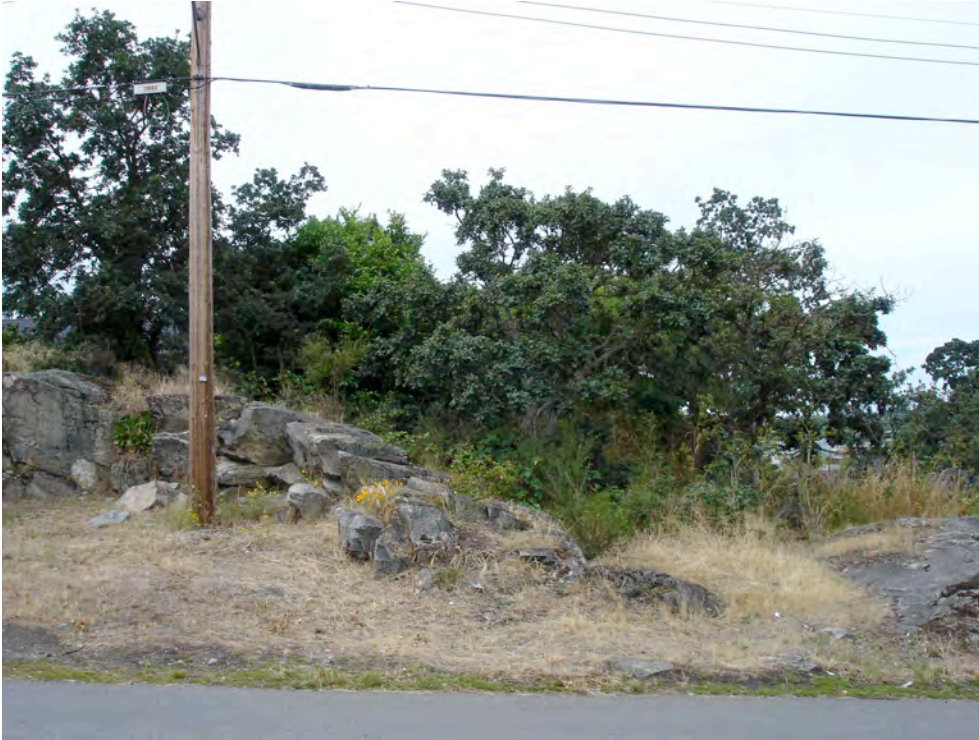
(Roadside entrance to 1436 Ryan Street)

1436 Ryan Street is a relatively small plot of city owned land located directly off the roadway on the upper slope of the Ryan street hill. The area is bordered by two houses on the east and west side as well as two more houses – one occupied, one abandoned) at the north end of the site. There are two steep slopes, one on the west side near the middle of the plot (a recently cleared blackberry patch), and one east, a grassy hill, near the road side entrance. Near the road side entrance is a granite rocky outcrop, which leads into a less-severe, sparsely treed north facing slope that twists and gullies down into a small, flat Garry Oak dominated stand. The crown class consists entirely of

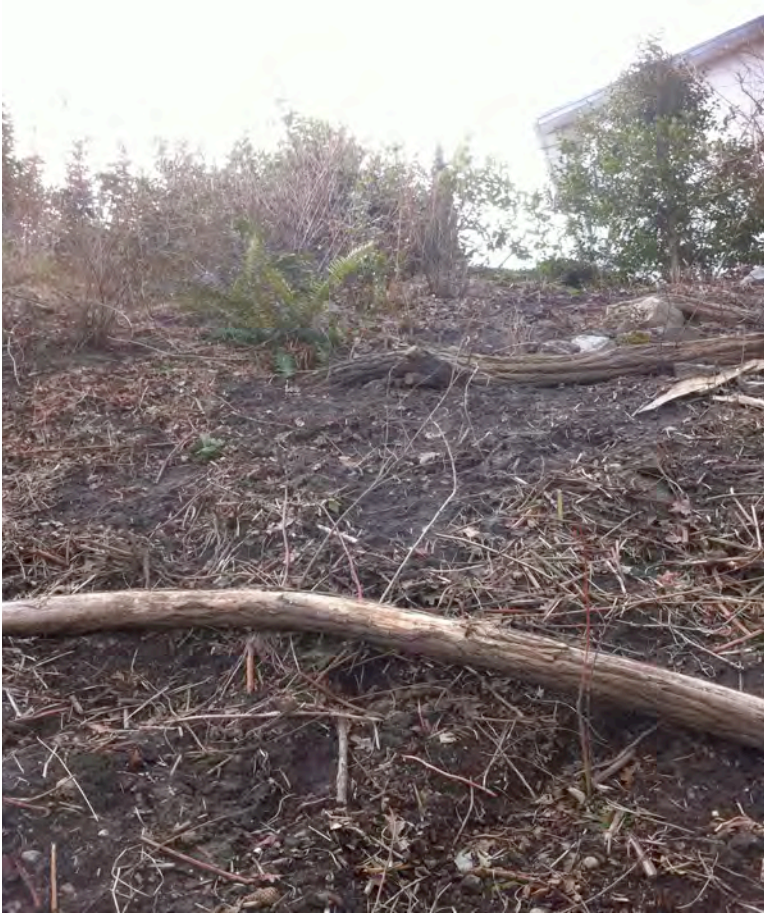
Figure 2.0 – “Eyebrow Terraces W/ Red Alder cuttings

After we constructed the terraces, Victoria had a couple of weeks of off and on heavy wind storms, so I went back to the site on March 18<sup>th</sup> and had to replace one out of the five terraces, as it had been blown down the slope. Two out of the three alder cuttings from the fallen terrace were lost; however, the other terraces and alder cuttings remained in tact.

Although it is an aggressive invasive species, the Himalayan blackberry roots acted to stabilize slope 1 [Table 6] at the site, which is a very wet, very steep slope. As a result, immediately following the cutting of the blackberry shrub layer and the removal of its roots, some type of slope stabilization had to be developed to avoid slope failure (Pollster, 2003). To do this, we built five ‘eyebrow’ terraces on the slope using driftwood and rocks [figure 2.0]. Small ditches were dug into the slope, where the logs were placed. We planted *Rosa nutkana*, *Mahonia aquifolium*, and Mock orange on soil above the logs to root the terraces, and placed and rocks about a foot to two feet in size under the logs to catch water running down the slope to irrigate what we had planted. We also staked live red Alder cuttings underneath the terraces, a process called “live staking” (Pollster, 2003), which we hope will take root and act to further stabilize the slope. Red Alder is a pioneering species that grows quickly in disturbed sites, such as roadside ditches, logging roads, and recently logged lots (Pojar, 2004) and can create a thick shrub layer that will ideally replace the blackberry layer that previously existed at the Ryan Hill site. For the Alder cuttings, I drove out to Langford, BC, about 20 minutes out of Victoria, BC, with a friend, and helper, Kevin Paterson, and clipped suckling alder branches roughly 1 meter in length and about the width of my thumb from young looking Alders (we cut branches that looked more reddish than brown and seemed to be from younger Alders rather than mature Alders) (Live Stakes, n.d.; Live Stakes for Restoration Plantings, 2009). We took 16 cuttings in total, which we stored in a 5L paint bucket filled with water overnight to keep alive, and planted at the site the next day.
